Management of Severely Worn Dentition via Full Mouth Rehabilitation: A Case Report

Abstract: It is very crucial to properly diagnose and treat Worn down dentition cases. As the treatment of this condition could be complicated and depends on many aspects, a thorough examination and sequenced treatment planning should be considered. Many aspects should be evaluated including, the causative factors, vertical dimension of occlusion (VDO), the remaining teeth structures and the periodontal condition around them. In this case, the Loss of posterior support was the most common causative factor along with the parafunctional habits the patient had. Mandibular recording device (Cadiax compact 2) was used to register the condylar and mandibular movements. The treatment included restoring the proper vertical dimension utilizing heat cured provisionals after confirming with an occlusal device. In this case many implant was placed in the posterior mandibular region along with metal ceramic porcelain fused to metal crowns to restore proper function and esthetics. Finally, an occlusal device was fabricated with and even bilateral simultaneous contact and canine guidance to protect the ceramic wor

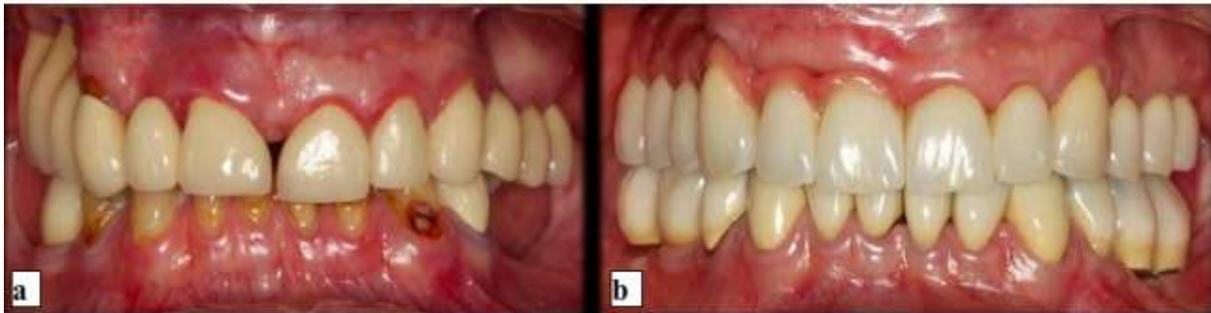
Figure 1. (a) Pre-operative, and (b) post-operative, frontal view of teeth

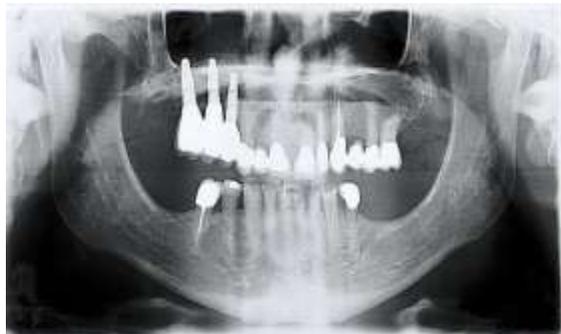
Seibert Class III deformity of the ridges was noted on the mandible residual ridge and also on the area of tooth #7. Full-mouth periapical radiographs displayed mild horizontal bone loss, and severe bone loss was visible in the right maxillary quadrant due to a previously failed implant. Overall, the patient demonstrated a generalized pattern of woven trabecular bone and intact lamina dura with a slight widening of the PDL space.

Figure 4. Pre-operative orthopantomogram

Radiographic evaluation also revealed several missing teeth with moderate horizontal bone loss of the mandibular alveolar ridge. No signs of pathology were noted. The patient was informed of the treatment
