Evaluation of Actual Field Ageing on Room Temperature Vulcanized Silicone Rubber Coating of Ceramic Insulators on 230/63 Substation

Abstract: Ceramic insulators are used in electrical substation. As outdoor insulators, the ceramic insulators are subjected to environmental stresses. In particular case, the insulators may severe high pollution exposure. Several methods are presently available to improve performance of post insulators under contaminated conditions. Recently, adding of hydrophobic agent on the insulators surface was present to improve the feature of ceramic insulators under polluted condition. The chief concerns with this method are the time of effectiveness of the coating, and insulator performance with time in service. This paper presents investigations on the performance of two different room temperature vulcanized (RTV) silicone rubber coating on the ceramic insulators after 7 and 11 years of field exposure respectively. The characteristics of RTV silicon rubber coated insulator were analyzed, such as, visual inspection, contact angle measurement and material diagnostic technique have been used to detect defective in service RTV Coated silicone rubber insulators.

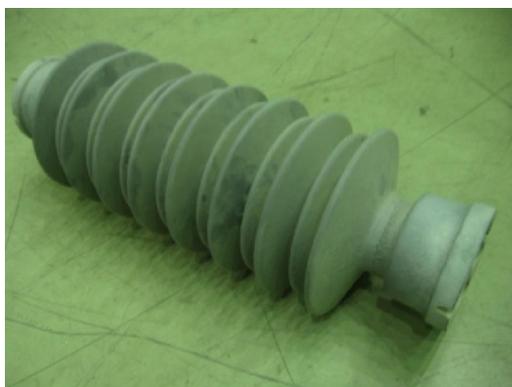
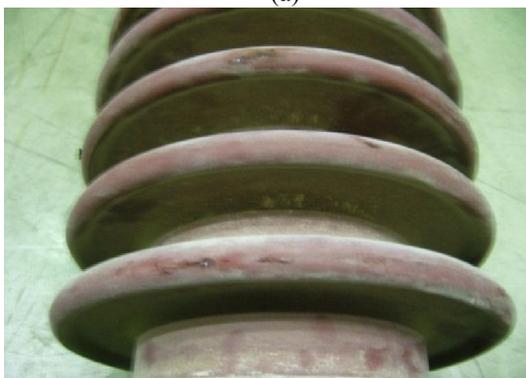
Figure 2. Visual observation a) after 7 years, b) after 11 years

A visual inspection revealed that all the samples presented small cracks and in their polymer sheath, corrosion and oxidation in the end fitting, especially in the live fitting. By looking at the insulators, no significant surface changes were found on the insulators and that was seen that the color of the surface compared to the virgin sample changed. Figure (2) shows the picture of insulator after 7 years and 11 years in service.

An increase in audible noise on insulation during moist conditions is the first sign of a loss of hydrophobicity, at least near the electrodes. When this occurs, it is imperative that a visual check be made. During the close-up visual inspection, if the RTV coating shows either a hard crust-like or soft putty-like appearance, then it will be necessary to take remedial action. The affected coating must be removed and fresh coating reapplied (Elini et al, 2009).

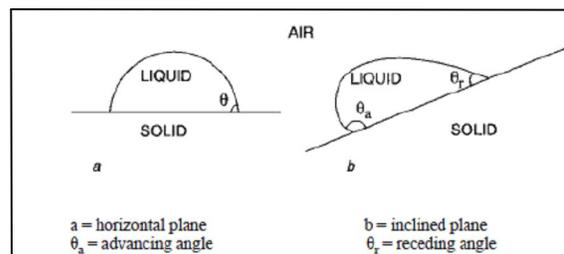
Figure 3. Definition of contact angle

Good outdoor insulators have a strong ability to repel water and pollution from their surfaces. This property is called as hydrophobicity. Hydrophobicity is indicated by its contact angle. Hydrophobic surface has contact angle more than 90° while hydrophilic less than 90° . Also, the contact angle (θ) between the water drops and the surface must be taken into account. The contact angle is defined in Figure (3). There exist two different contact angles, the advancing contact angle (θ_a) and the receding contact angle (θ_r). A drop exhibits the angles on an inclined surface (IEEE Std 1523, 2002).

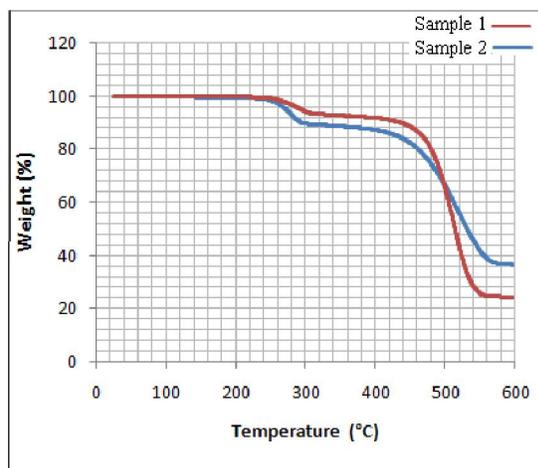
Figure 4. TGA curve for two RTV coating

The weight loss and rate of weight change in a material, as a function of temperature was recorded for both aged and virgin silicone composites. The temperature is increased from 25 to 600°C . Figure (4) shows the TGA curve of RTV silicone rubber coated insulator samples. The samples are chosen after separating the coated layers from the insulator surface. It can be observed that increasing temperature up to $\sim 200^\circ\text{C}$ does not affect on samples' weight. Figures show that over 200°C all samples decompose at two stages. The first is due to the conversion of ATH to Al_2O_3 . During this reaction, water is released. Also it has been found that evaporation of LMWS species can be started at this stage (Ahmadi-Joneidi et al. 2013).

It can be seen that temperature of First drop in sample 1 and sample 2 are 210°C and 220°C . The second weight loss belongs to the degradation of silicone rubber in forms of LMWS, cross-linked silicone elastomer, and silica. It can be observed that temperature of second drop in aged and virgin sample are 290°C and 300°C respectively.

First drop in the sample weights is not major and Water started to be detected when the weight loss began at just over 190°C . It ended at the same time when the first weight loss finished. However, the second drop is caused by the break of the side chain (CH_3) from the Si backbone (Si-O-Si). At the end, only a non-volatile residue remains. Residual ash in sample 1 was 26% and in sample 2 was 35%.

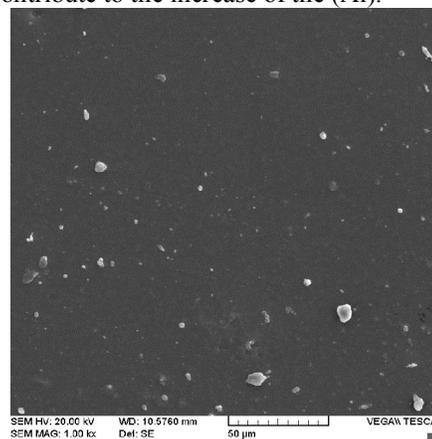
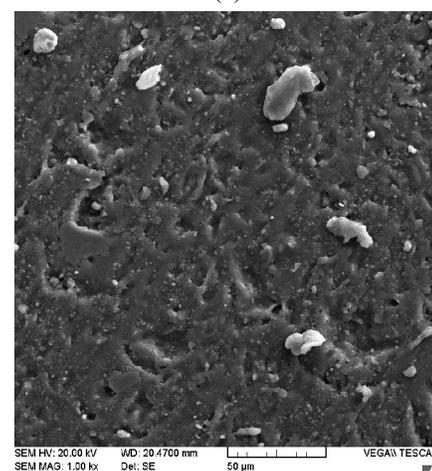
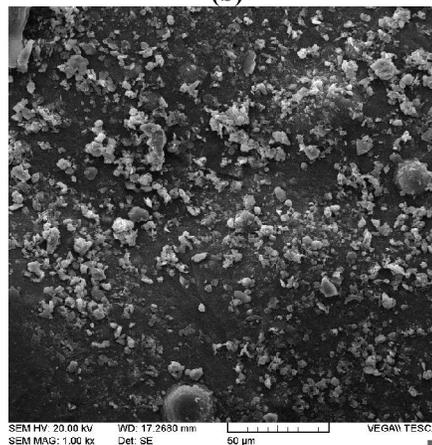
Figure 5. SEM analysis on the surface of samples, (a) Virgin sample, b) Sample 1, C) Sample 2

Figure (5) show the micrographs for virgin and aged samples at 1000x. The overall observation is that there is no major degradation, such as cracking; also the sample 1 has a smooth, more homogeneous and less porous surface while the surface roughness and porosity increases with ageing for sample 2 after 11 years.

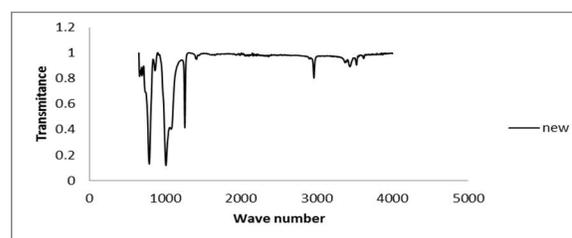
Figure 6. FTIR analysis of Virgin sample

Figures (6-8) show ATR-FTIR transmission spectra as a function of time before and after ageing. The transmission peaks at 3570 and 3670 cm^{-1} (O-H), 2960 cm^{-1} (C-H in CH_3), 1260 cm^{-1} ($\text{Si}-\text{CH}_3$), 1015 cm^{-1} (Si-O-Si) and 795 cm^{-1} ($\text{Si}-\text{CH}_3$)₂ correspond to the molecular vibration. As can be seen from these figures, pick of IR spectra of aged insulator samples compared with virgin samples was decreased which means the number of C-H bonds decreases. Pick areas in Si- CH_3 in virgin and aged samples are 85,

81.4 and 79 respectively. Also, Peak areas in Si-O-Si in virgin, sample 1, sample 2 are 202, 176.4 and 167.1 respectively. Increasing of ratio (Si-O-Si/Si- CH_3) is an index for ageing. In virgin sample, peak area is 0.42 and with increasing ageing it reached to 0.473. Table (4) shows the result of ATR/FTIR analysis.
