## Performance Of Concrete Structure Against Construction Tolerances And Various Kinds Of Imperfections

**ABSTRACT:** Growing needs in construction industry has put the performance of concrete structure to perform as intended as a foremost concern. Concrete structure deviate from specifications, quality standards & design plans due to various conditions and challenging circumstances and as a result, as built performance of structure is compromised. Depending upon the type and magnitude of imperfections, accordingly serviceability is affected. However, only those concrete structures which are constructed in accordance with design parameters, specifications and quality control standards, perform satisfactorily. No structure can be constructed with 100% exactness as per drawings and specifications. Actually, during execution phase, accidentally, due to lack of competency, lack of engineering knowledge, lack of insight of technical specifications and due to poor workmanship, various kinds of imperfections are resulted which affect the serviceability and performance of concrete structure. Typically, these imperfections include concrete cover, size of structure members, plumb, offset of

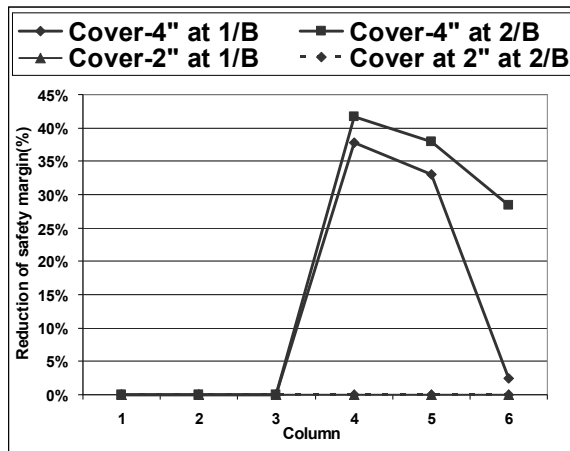
starts to degrade ACI 117-90 allows only  $-1/2''$  tolerance in concrete cover for members sizes over  $12''$  [1]. Against concrete cover  $4''$  and  $2''$  results are plotted in Fig-3.

Against imperfection  $4''$  it has been observed that safety margin has been reduced 38%, 33% and 2% at location 1/B and 42%, 38% and 28% at location 2/B respectively for columns 4, 5 and 6 as shown in fig-1. Hence, structural performance accordingly is affected.

Concrete cover ( $2.0''$ ) as per ACI specified tolerance limit has negligible effects on structural performance as shown in Fig-3.

Figure 3: Effect of concrete cover on structure performance

Concrete cover was varied from 2.5" to 3", 4" and 2" in the model. It has been observed from the analysis results that when magnitude of concrete cover gradually increases then structural performance

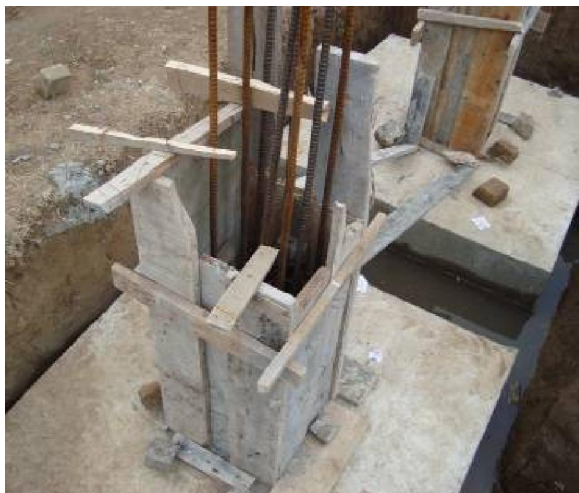
Fig-4 and Fig-5 shows how this imperfection occurs due to poor inspection practices and use of sub-standard form work for structural members in developing countries like Pakistan.

Figure 4: Poor form work and improper concrete cover

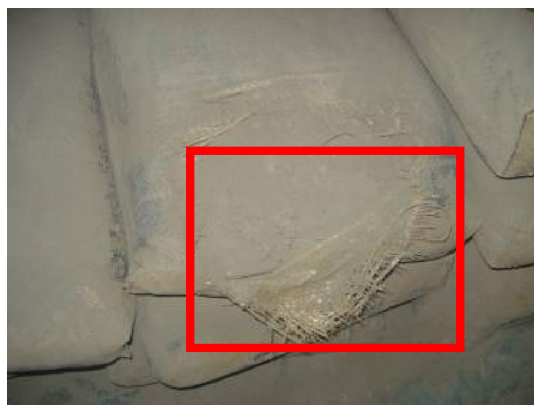
Fig-7 and Fig-8 show the poor quality control on the materials used and poor workmanship of concreting which cause significant variations in the compressive strength of concrete. Fig-7 and Fig-8 show inadequate storage and occurrence of excessive honey combing in developing countries like Pakistan. This can result an adverse effects on structural performance. So measures should be taken to meet design strength.

Figure 7: Poor storage of cement bags

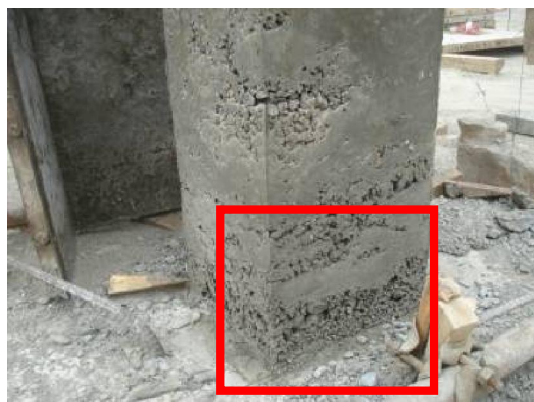
Figure 8: Excessive honey combing in structural column

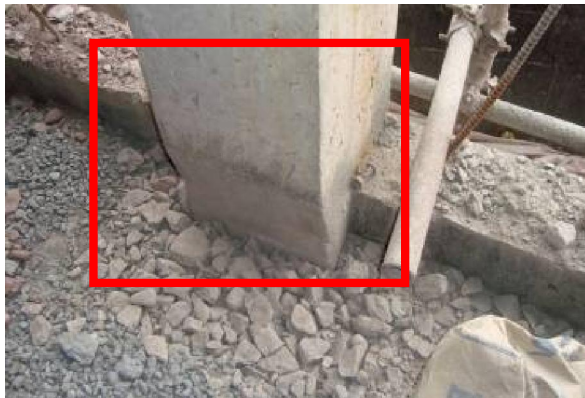
Fig-11 shows how reduction in size of structural members occurs due to poor inspection practices. It is worth noting that what will happen in case of designed seismic activity when the safety is already reduced due to reduction in member sizes because of poor construction.

Figure 11: Varying column cross section

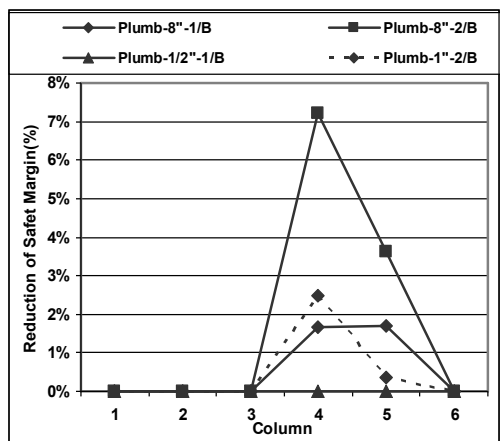
For plumb imperfection of 8" and 1/2" for column 1/B and for 8" and 1" for 2/B, results are also shown in Fig-12. It has been confirmed from the results that only negligible effects has been observed on the performance of the structure even for sizeable magnitude of imperfections (8"). Against imperfections 8" only 7% reduction in safety margin has been calculated which may be taken as negligible.

For comparison, ACI tolerances of 2% are also plotted in Fig-12.

Figure 12: Effect of column plumpness on structure performance

Plumb of columns were changed from 0" to 1/2", 1", 2", 3", 4", 5" and 8" for top five columns at locations 1/B and 2/B one by one. It has been observed that this imperfection has negligible effects on the performance of structure hence structure safety is not significantly affected. From aesthetic point of view, plumpness of columns is much critical. Therefore ACI 117-90 allows only 1/2" tolerance for exterior columns and 1" for interior columns [2].

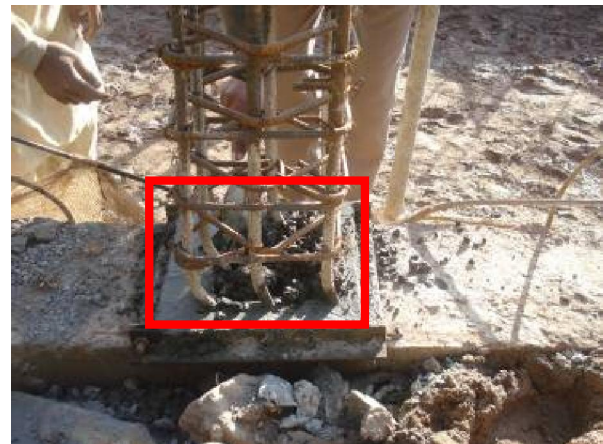
Fig-13 and Fig-14 demonstrates how out of plumb of columns occur in structure due to poor workmanship and lack of proper inspection in developing. Straightness of structure is much critical from aesthetic consideration and that is why ACI has imposed stringent values on tolerances.

Figure 13: Plumness of column

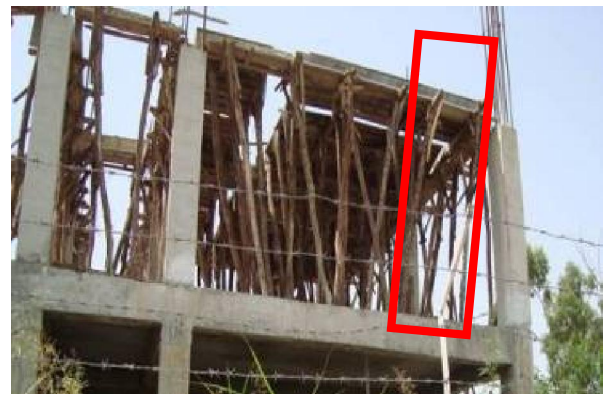
Figure 14: View of column out of plumb

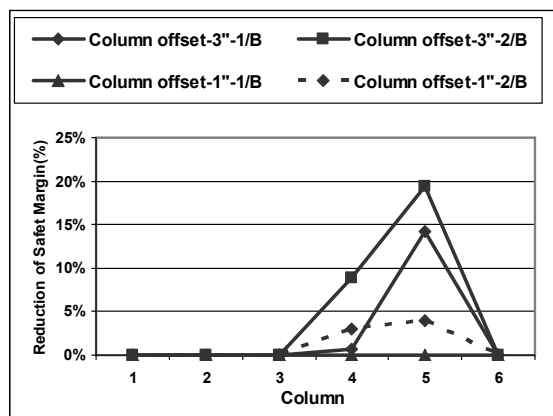
At locations 1/B and 2/B, top five columns were given offset 1", 1.5", 2", 2.5" and 3" one by one. Results from Fig 15 confirms that this imperfection has slight effects on structural performance. ACI 117-90 allows 1" tolerance for both exterior and interior columns [2].

Against imperfection parameters 3" and 1" results are plotted in Fig 15. It is clear from Fig 5 that for offset 3" in column, maximum 20% reduction in safety margin has been observed.

ACI allowable limit 1" has negligible effects (4%) on structural safety margin which is also plotted in Fig-15 for reference.

Figure 15: Effect of column offset on structure performance

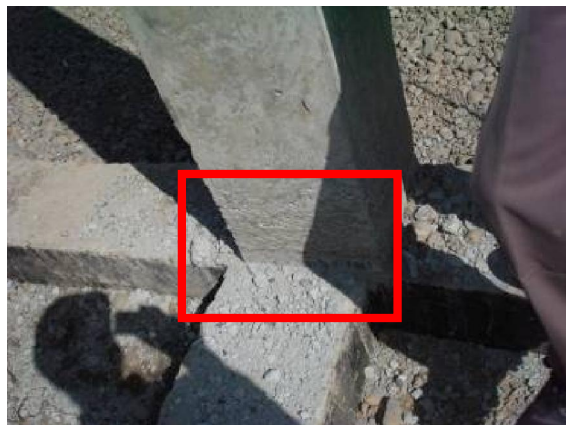
Fig-16 and Fig-17 shows how deviations in lateral alignment of structure occurs due to inadequate layout practices and lack of proper inspection practices in developing countries like Pakistan.

Figure 16: Column off set view

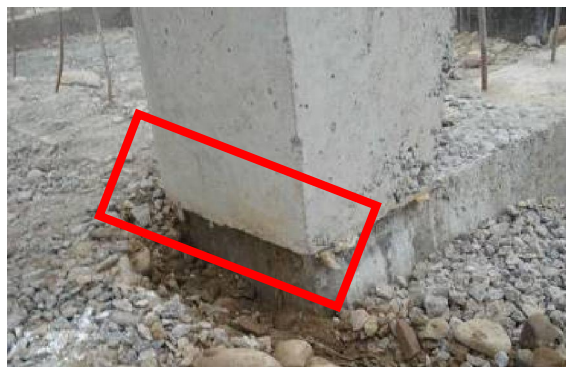
Figure 17: Offset of column

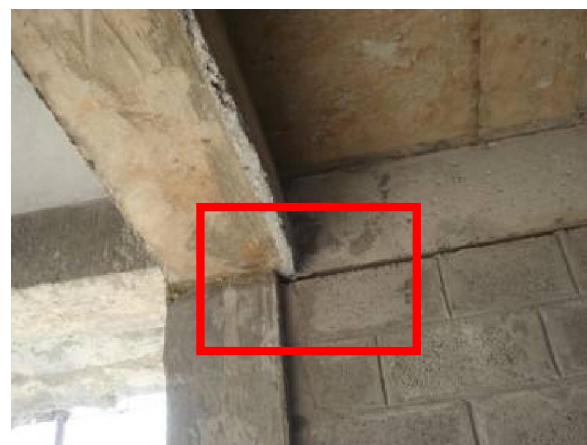
Fig-18 and Fig-19 are a few examples of imperfections in lateral alignment of beams in real construction in Pakistan.

Figure 18: Offset of beam

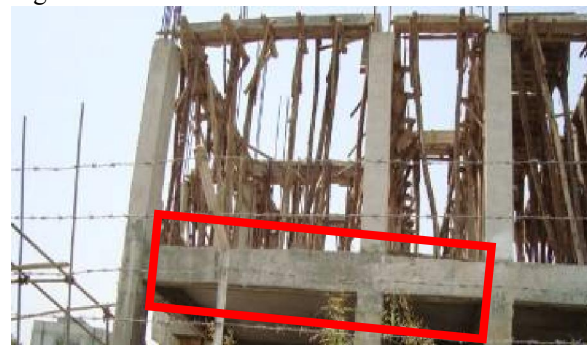
Figure 19: Offset of Beam

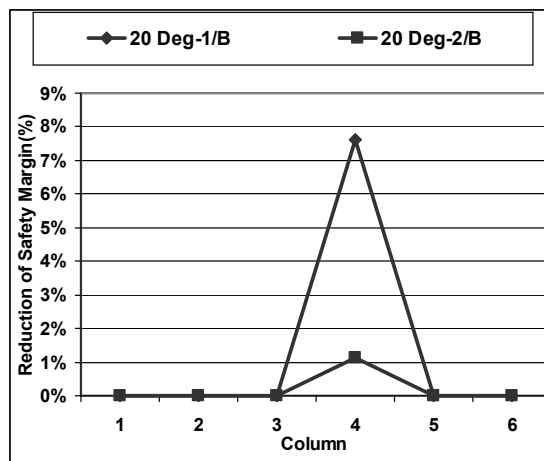
Against rotation 20 degree, maximum 8% reduction in safety margin has been observed as shown in Fig 20.

Fig 20: Effect of column rotation on structure performance

At location 1/B and 2/B, top five columns were rotated from 0 degree to 5 degree, 10 degree, 15 degree, and 20 degree. Results confirm that slight effects on structure safety has been observed. ACI code does not give any guidance for this type of imperfection. This imperfection is much critical aesthetically. However, if the magnitude of this imperfection increases, aesthetic of the structure is affected accordingly.

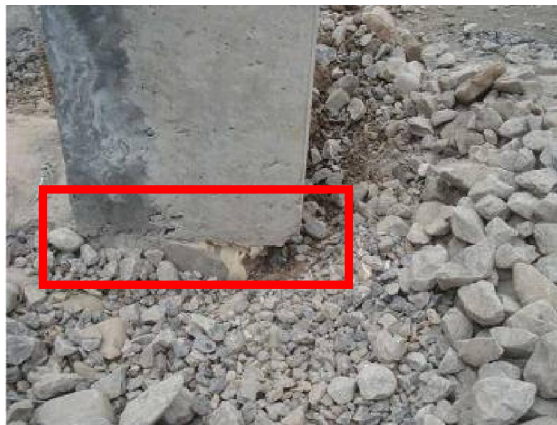
Figure 21: shows a practical example of column rotation in column axis.

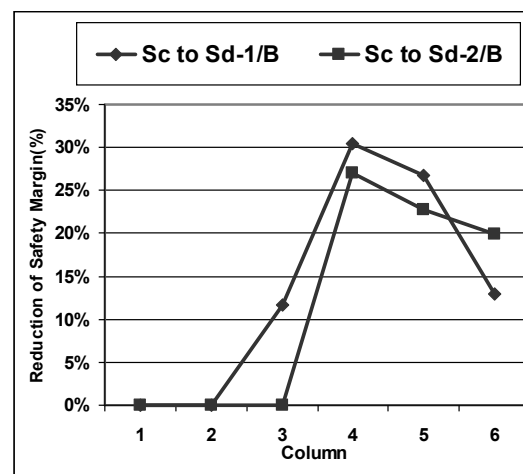
The results are plotted in Fig-22 below for specific columns 1/B and 2/B and have noted that safety margin has been reduced considerably by 58%, 59% and 28% at location 1/B and 60%, 46% and 41% at location 2/B for columns 4, 5 and 6. Therefore, 50% safety of the structure is compromised based on only change in soil profile. Therefore proper soil investigation should be of prime importance for the sustainability of structure otherwise will damage the performance of the structure.

Fig 22: Effect of variation in soil profile types on structure performance

Soil profile was changed from  $S_C$  to  $S_D$  for all structural components of model under consideration. Result reveals that this variation from

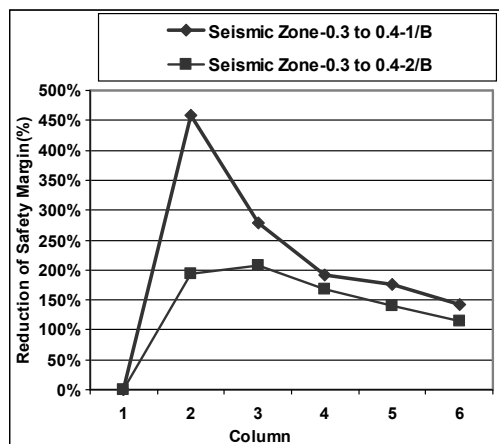
Research results are shown in Fig-23 for typical columns at locations 1/B and 2/B respectively. It is clear from the research analysis that safety margin for all structure members have drastically been reduced due to this change in seismic zone and

Fig 23: Effect of Seismic zone on structure performance

Some times designer or client only for the sake of economy, designs for low seismic zone and are actually placed in high seismic zone. They may lead to catastrophic potential impacts during earthquake. The structure performance is analyzed for variation in seismic zone. Seismic zone was changed from 3 to 4 and the results were compiled. Results show that this change in seismic zone has resulted in catastrophic reduction of safety margin and whole structure has failed in performance as shown in Fig 9.
